Manhole Inspection Summary

Manhole # S15WW1001MH

Insp Date: **5/1/07 1:43 PM**

Location Address: **NORTHERN PKWY**

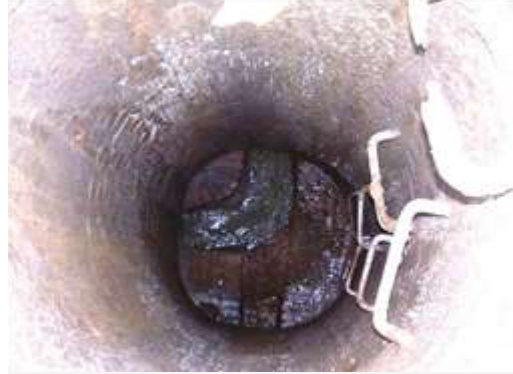
Top View

Corroded and missing steps. Evidence of surcharge - Bench debris.

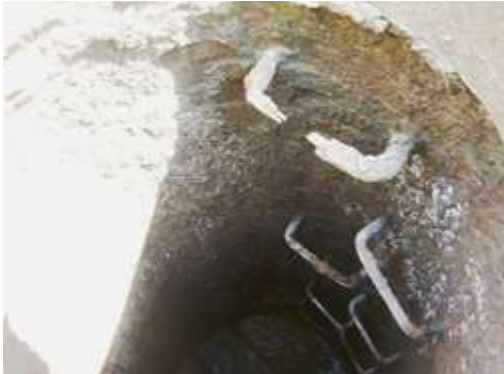
Defect

Frame leaks. Corbel deterioration and infiltration.

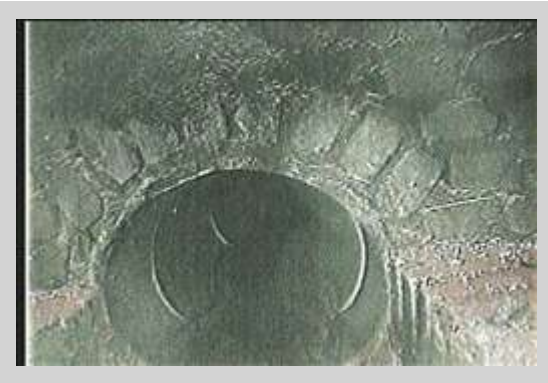
15 in. Circular Gravity Sewer Pipe Out @ 12 O'Clock

Barrel deterioration and infiltration. Bench deterioration.

Infiltration: **Evidence** Pipe Seal Cond: **Cracked**

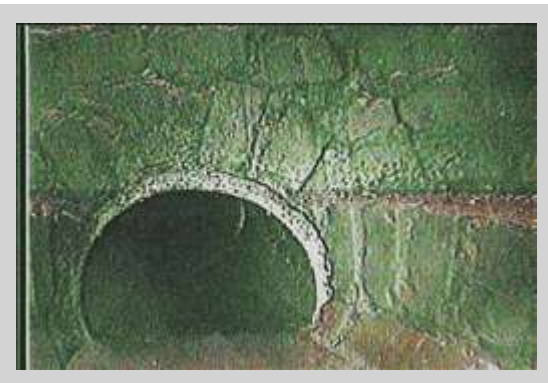
10 in. Circular Gravity Sewer Pipe In @ 9 O'Clock

Barrel deterioration and infiltration. Channel deterioration.

Infiltration: **Evidence** Pipe Seal Cond: **Cracked**
